Manhole Inspection Summary

Manhole # S21W__034MH

Insp Date: **5/7/09 1:58 PM**

Location Address: **1929 MAISEL ST**

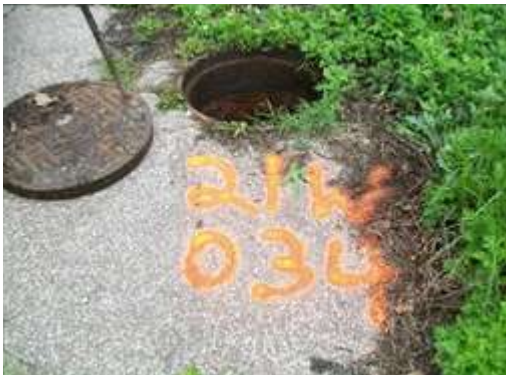
MISC.

PAVEMENT MARKED

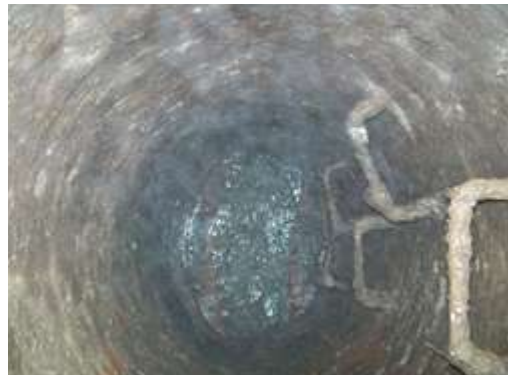
Defect 1

Condition: ☐ Sound ☐ Cracked ☐ Root Intrusion ☐ Loose Brick ☒ **Deteriorated**

Steps Count: **9** Missing: **0** ☒ **Corroded**

Surcharge ☒ **Evidence Of Surcharge** Depth: **8** (ft.) ☐ Active Surcharge Present

Corroded Steps, Deteriorating Corbel and Barrel, Surcharge Evidence

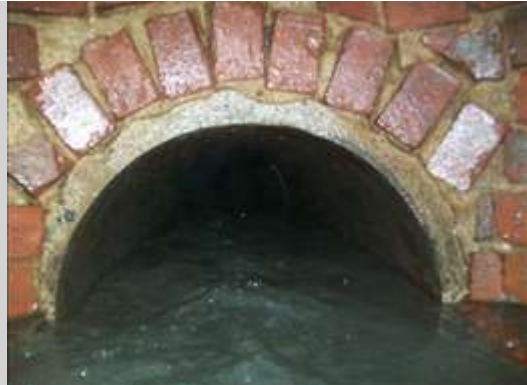
12 O'Clock Outflow

18 in. Circular Gravity Sewer
Pipe Out @ 12 O'Clock

Pipe Height: **18** (in.) Rod and Bar (Angled)
Pipe Material: **Clay** ☐ Pipe Lined
Invert Depth: **15.77** (ft.) Flow Characteristics: **Fast**
Deposits: ☒ None ☐ Mud ☐ Sludge ☐ Debris ☐ Grease
Silt Depth: **0** (in.) Deposits Extent:
Infiltration: **None** Pipe Seal Cond: **Sound**

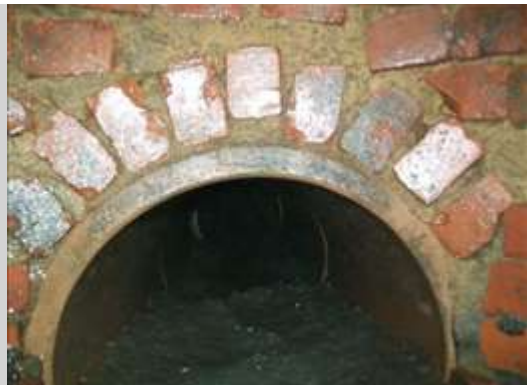
5 O'Clock Inflow

18 in. Circular Gravity Sewer
Pipe In @ 5 O'Clock

Pipe Height: **18** (in.) Rod and Bar (Angled)
Pipe Material: **Clay** ☐ Pipe Lined
Invert Depth: **15.50** (ft.) Flow Characteristics: **Fast**
Deposits: ☒ None ☐ Mud ☐ Sludge ☐ Debris ☐ Grease
Silt Depth: **0** (in.) Deposits Extent:
Infiltration: **None** Pipe Seal Cond: **Sound**
